## **URGENT RECALL NOTICE**

November 8, 2006

**Subject:** Product Safety Issues

**Affected Products:** FlexiView 8800 Mobile C-Arm, OEC® UroView 2800, OEC® 9800, OEC® FluoroTrak 9800 Plus, OEC® 9800 Plus, OEC® 9800MD Motorized C-arm System, and OEC® Miniview 6800

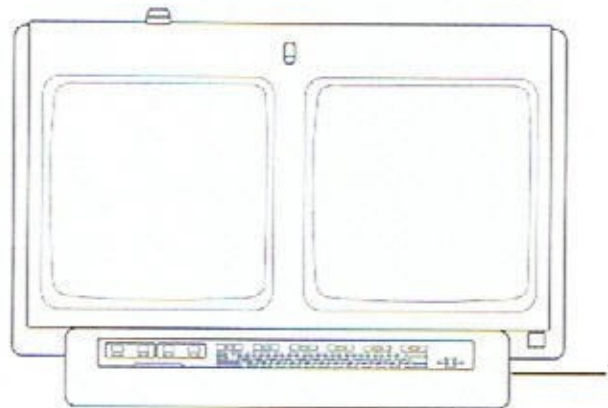
### SUGGESTED PLACEMENT OF STICKER ON SYSTEM

GEHC OEC has become aware of a potential problem with the above-indicated products where the C-arm may lock-up. Specifically, during system usage, the system may fail to function (produce live x-rays), and the collimators may close. In addition, the system display may indicate that the system is active (such as sound and/or light displays) when, in fact, the system is not producing live x-rays. The left monitor of the system will not update (no live fluoroscopy). There will be no radiation emission occurring despite the audible and visual indicators. If it is suspected that the system has emitted an uncommanded radiation exposure the user should contact GEHC to have the exposure logs reviewed to confirm if an exposure was made.

Should your OEC System experience a Lock-up, restarting (rebooting) the system should restore system functionality. The restarting (reboot) procedure for OEC 9800 Plus, OEC Flexiview 8800, and OEC UroView 2800 will take less than 3 minutes. **Images saved prior to the system locking up will be restored and are retrievable. Images not saved prior to the system failure will not be restored.** At this time a corrective solution for the OEC 9800 Plus, OEC Flexiview 8800, and OEC UroView 2800 is under investigation. Your facility will be notified as soon as a solution has been identified.

Instructions for rebooting (restarting) the system are located in the Operators Guide. In addition enclosed is a sheet of supplemental stickers, including instruction for attachment, which demonstrates the restart steps. These stickers should be promptly attached to your system(s) as indicated below (suggest placement in location #1).

<b>CAUTION</b>	<b>POWER OFF</b> 1. Wait 1 minute after performing any system function. 2. Press the power switch. 3. Wait for the system to power off.
<b>DATA LOSS</b>	<b>RESTART</b> 1. Wait 10 seconds. 2. Press power switch to restart.

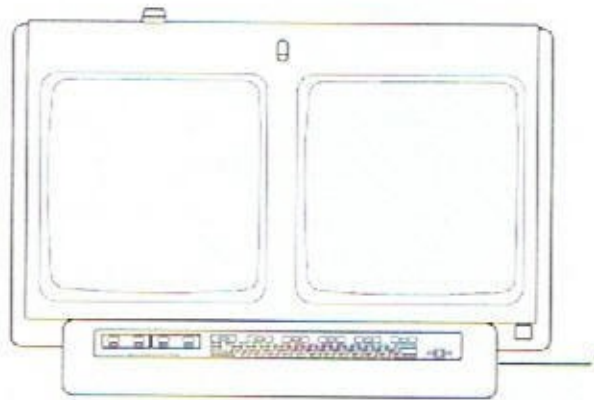
#### SUGGESTED PLACEMENT OF STICKER ON SYSTEM

When the image directory is accessed and thumbnail images are used to recall patient images, incorrect images may be displayed or there may be an inability to locate images on the system. The actual images, however, are labeled with the correct patient information, and may be located within another patient's file.

To reduce the occurrence of this issue users should follow the correct power down procedure.

The supplemental stickers should be installed on your system(s) promptly following the enclosed instructions and as indicated below (suggest placement in location #1).

<b>⚠ CAUTION</b>	<b>POWER OFF</b> 1. Wait 1 minute after performing any system function. 2. Press the power switch. 3. Wait for the system to power off.
<b>DATA LOSS</b>	<b>RESTART</b> 1. Wait 10 seconds. 2. Press power switch to restart.

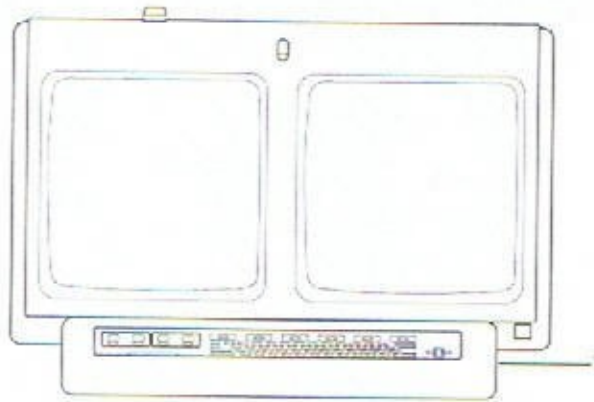
### SUGGESTED PLACEMENT OF STICKER ON SYSTEM

FlexiView 8800 Mobile C-Arm, OEC® UroView 2800, OEC® 9800, OEC® FluoroTrak 9800 Plus, OEC® 9800 Plus, OEC® 9800MD Motorized C-arm System, and OEC® Miniview 6800 may stall during its boot cycle causing a delay in usage. If this condition persists for longer than a minute, the system is stalled.

Rebooting the system should clear the issue and restore system functionality. When rebooting the system for this issue, before reapplying power, it is important to place the power switch in the OFF position and wait **10 seconds**. Should the system fail to reboot a second attempt at rebooting may be required. These instructions are located in the Operators Guide.

**In addition enclosed is a sheet of supplemental stickers, including instructions for attachment that demonstrates the restart steps. These stickers should be promptly attached to your system(s) as indicated below (suggest placement in location #1).**

<b>CAUTION</b>	<b>POWER OFF</b> 1. Wait 1 minute after performing any system function. 2. Press the power switch. 3. Wait for the system to power off.
<b>DATA LOSS</b>	<b>RESTART</b> 1. Wait 10 seconds. 2. Press power switch to restart.
