URGENT RECALL NOTICE

November 8, 2006

Subject: Product Safety Issues

Affected Products: FlexiView 8800 Mobile C-Arm, OEC® UroView 2800, OEC® 9800, OEC® FluoroTrak 9800 Plus, OEC® 9800 Plus, OEC® 9800MD Motorized C-arm System, and OEC® Miniview 6800

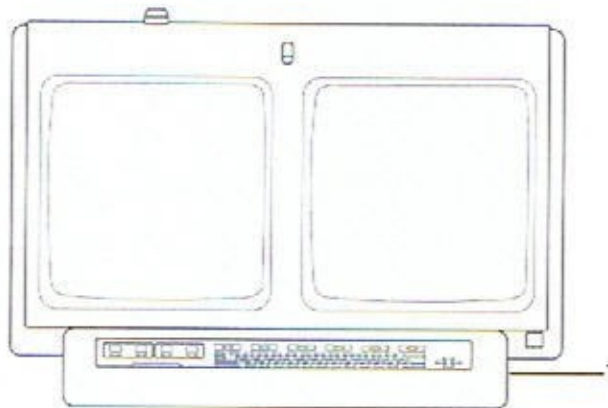
SUGGESTED PLACEMENT OF STICKER ON SYSTEM

GEHC OEC has become aware of a potential problem with the above-indicated products where the C-arm may lock-up. Specifically, during system usage, the system may fail to function (produce live x-rays), and the collimators may close. In addition, the system display may indicate that the system is active (such as sound and/or light displays) when, in fact, the system is not producing live x-rays. The left monitor of the system will not update (no live fluoroscopy). There will be no radiation emission occurring despite the audible and visual indicators. If it is suspected that the system has emitted an uncommanded radiation exposure the user should contact GEHC to have the exposure logs reviewed to confirm if an exposure was made.

Should your OEC System experience a Lock-up, restarting (rebooting) the system should restore system functionality. The restarting (reboot) procedure for OEC 9800 Plus, OEC Flexiview 8800, and OEC UroView 2800 will take less than 3 minutes. **Images saved prior to the system locking up will be restored and are retrievable. Images not saved prior to the system failure will not be restored.** At this time a corrective solution for the OEC 9800 Plus, OEC Flexiview 8800, and OEC UroView 2800 is under investigation. Your facility will be notified as soon as a solution has been identified.

Instructions for rebooting (restarting) the system are located in the Operators Guide. In addition enclosed is a sheet of supplemental stickers, including instruction for attachment, which demonstrates the restart steps. These stickers should be promptly attached to your system(s) as indicated below (suggest placement in location #1).

CAUTION	POWER OFF 1. Wait 1 minute after performing any system function. 2. Press the power switch. 3. Wait for the system to power off.
DATA LOSS	RESTART 1. Wait 10 seconds. 2. Press power switch to restart.
